# SKI TOURERS' ASSOCIATION

## Re: KUNAMA DISASTER

On the morning of Thursday the 12<sup>th</sup> July, 1956 an avalanche fell from the summit of Mount Clarke, Main Range, Kosciusko. Kunama Hutte was wrecked and an occupant fatally injured. The victim was Roslyn Wesche, only child of Mr. and Mrs. Venn Wesche, of Sydney.

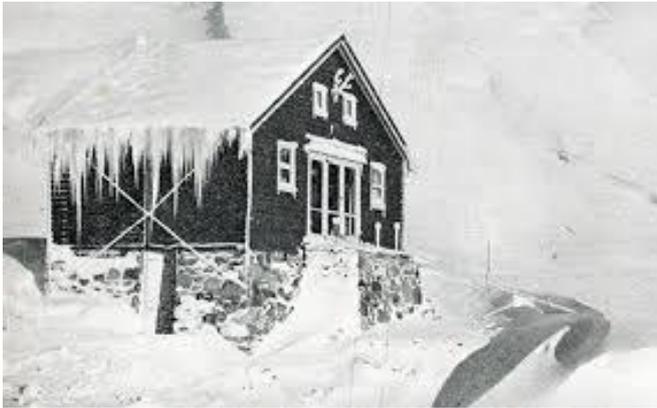
**Kunama Hutte prior to the 1956 avalanche**

Structurally, the building comprised a granite basement, a main floor in stud frame and weatherboard construction, plus a gallery under a steeply pitched roof. For additional strength the stud frame construction was tied to the masonry by wire ropes at each corner from the top plates to chains embedded in the masonry, with cross bracing by wire ropes on two sides. The impact of the avalanche was so great that in one observable instance the eye hook linking the wire rope to the chain was straightened out.

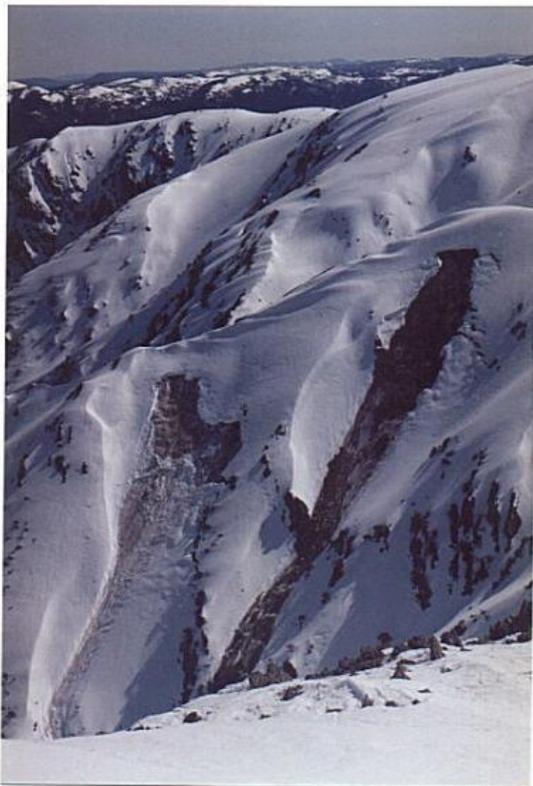
**The avalanche path on Mt Clarke**

The avalanche that destroyed Kunama Hutte came down the entire length of the north face of Mt Clarke about 7.20 am on the morning of Thursday the 12<sup>th</sup> July, 1956. This avalanche originated at the summit of Mt Clarke and swept to the floor of the basin a track some 50 yards wide at its maximum. Mt Clarke forms the southern segment of the Kunama Basin. The altitude of Mt Clarke is approximately 6,900 ft. The northern slope comprises some rock crags near the summit and a fairly even moderate gradient to the floor of the valley. The centre of the segment comprising the Kunama Basin is Mt Northcote 6, 991 ft. which has very steep easterly slopes into the Basin. To the north is Mt. Lee with a steep summit section training into moderate slopes. The floor of the Basin is at an approximate altitude of 6,200 ft. In the month of July the prevailing wind is from the west. Most of the precipitation in snow comes from westerly directions. Thus the east facing slope of Mt Northcote is subject to extremely heavy deposition of snow; also the south facing slopes of Mt Lee. The north facing slopes of Mt Clarke generally carries the least amount of snow.

How, then, did the slope avalanche? To answer this question we must consider the summit of Mt Clarke. Here the wind, blowing with much higher velocity, steadily up on a high pure powder snow cornice. The critical hour arrived on the morning of the 12<sup>th</sup>. The wind and snowstorm during the night had built the cornice to the point of collapse with wind-blown powder. The moment of disaster came about 7.20 am. A powder snow avalanche and cornice avalanche originated. This became channelled between two rocky outcrops, which concentrated its effect. In turn this triggered of a larger avalanche comprising the unstable snow slope below. Snow to a depth of two or three feet was set in motion. Such of it had sufficient internal cohesion to come down in big blocks. The situation can be likened to a stone shattering a sheet of non-splintering safety glass. A major avalanche was generated (speed of movement not known) and it impacted full on the back wall of Kunama some six hundred feet below. The back of the building was crushed inwards, and the momentum of the avalanche moved the building forward half its length whereupon the gallery and roof toppled over into the snout of the avalanche as its force became spent. The site of Kunama is on a round knoll (at the foot of the slope) on which the building was literally perched. This natural protection was of no avail due to deep snow in the area around the knoll. Kunama itself was free of snow above main floor level owing to the wind scour around the building.

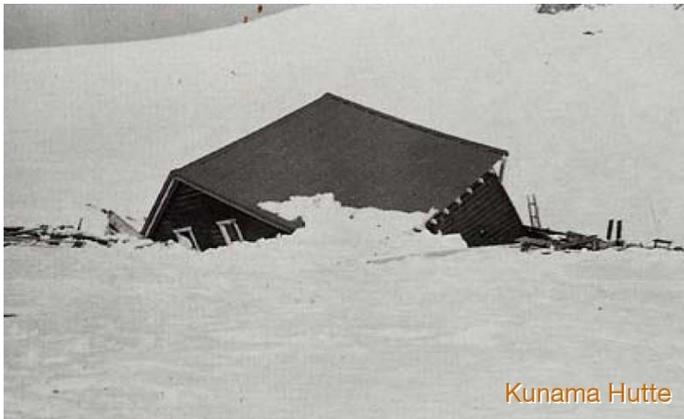
Kunama Hutte south western corner following avalanche hit.

When I was released from my position I saw that the whole Hutte had been moved forward off its foundations with the northern wall laying flat and badly broken on the snow in the wind scour, the gallery was at an angle of 45 degrees and most of the southern and eastern parts of the building were badly damaged and under snow.

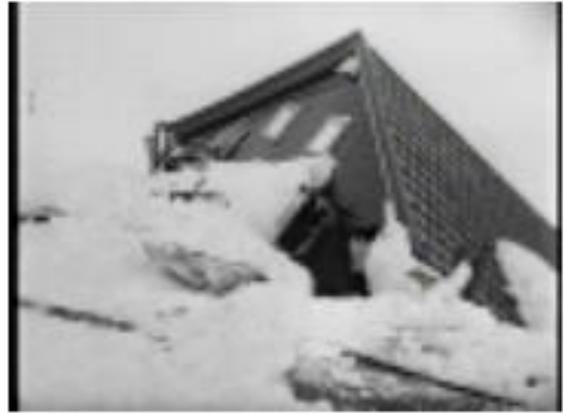
Kunama Hutte destroyed by the avalanche

There appeared to be a safety factor in as much as the building did move with the avalanche, which slowed the tempo of its collapse, and seemingly saved ten inhabitants from injury that could have resulted from being buried in snow and debris. In abstract, collapsing timber may be a lesser evil than falling masonry as in earthquake areas. Kunama Hutte is a total wreck caused by unforeseeable effects of a freakish snow storm in an area where no danger was anticipated.
